OPERATION SNAPPER

Project 6.4

OPERATIONAL TESTS OF RADAR AND PHOTOGRAPHIC TECHNIQUES FOR IBDA

REPORT TO THE TEST DIRECTOR

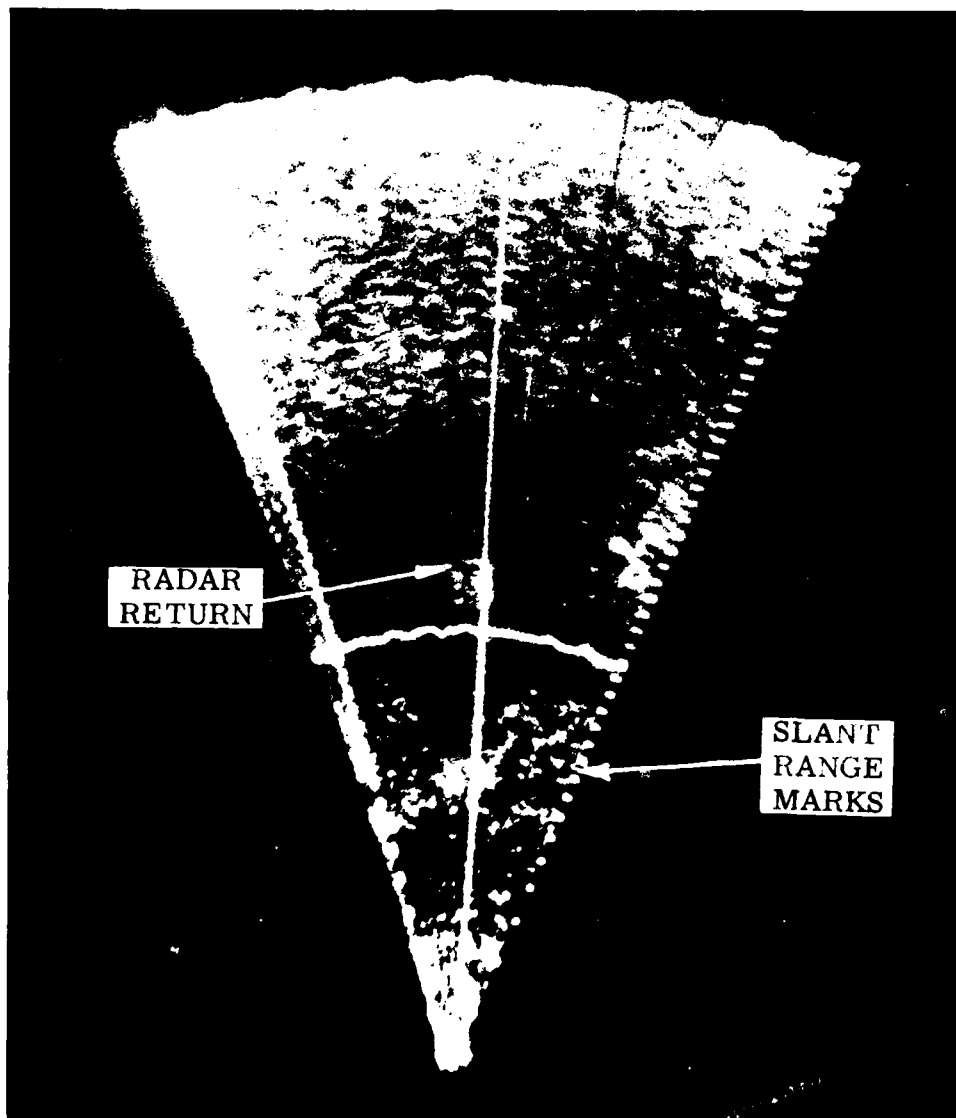
Fig 4.1 Radar Photography, Shot 3. This picture was secured by Tiger 3, and illustrates the type of return secured when the antenna happens to be oriented on the bomb at T_0 . Note the 1500-foot slant range marks on this and subsequent pictures.

At detonation, a strong point return of short duration.
(See Fig 4.1)

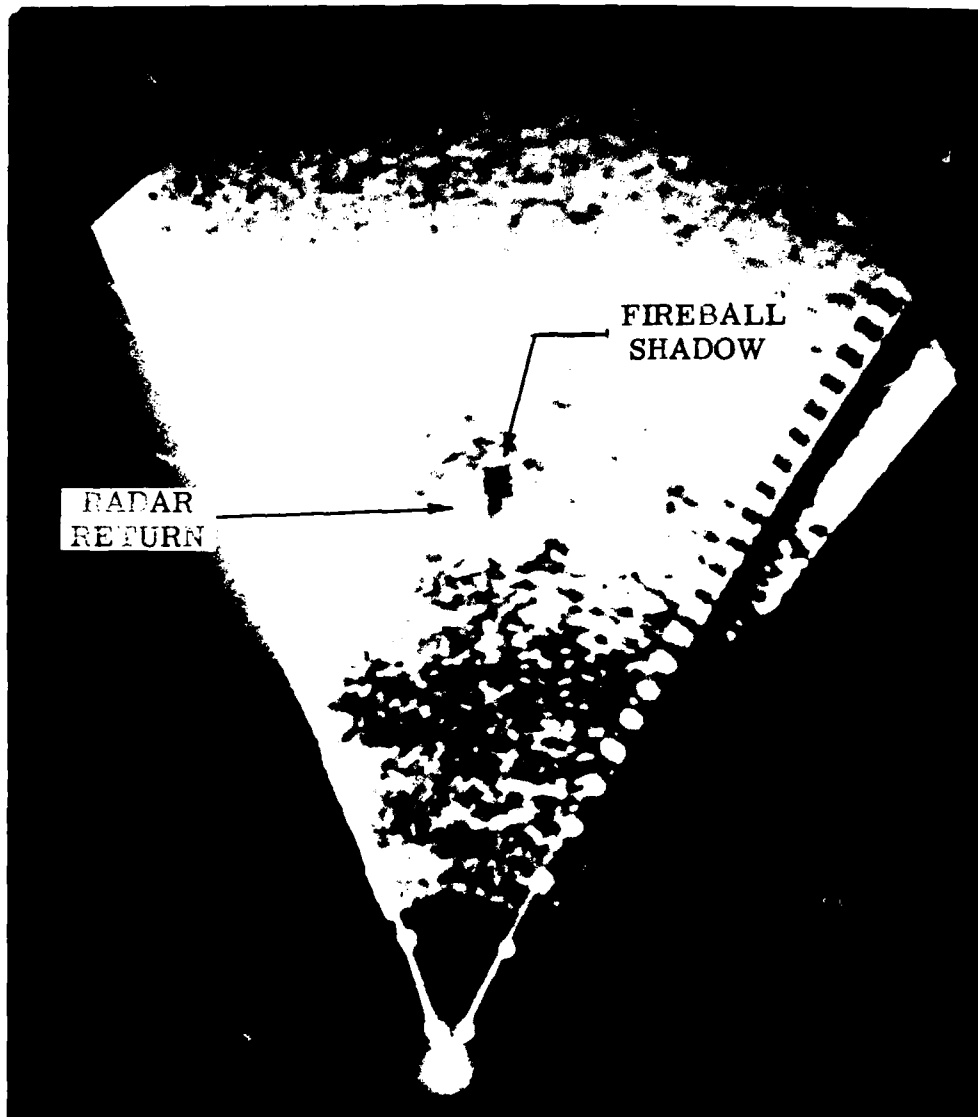
Fig 4.2 Radar Photography, Shot 4. This picture was secured by Tiger 1, and illustrates a so-called horseshoe return. All IBDA parameters may be secured from photography of this type, although attainable yield accuracy is presently unknown.

A horseshoe return of possibly 2-3 seconds duration.
(See Fig 4.2)

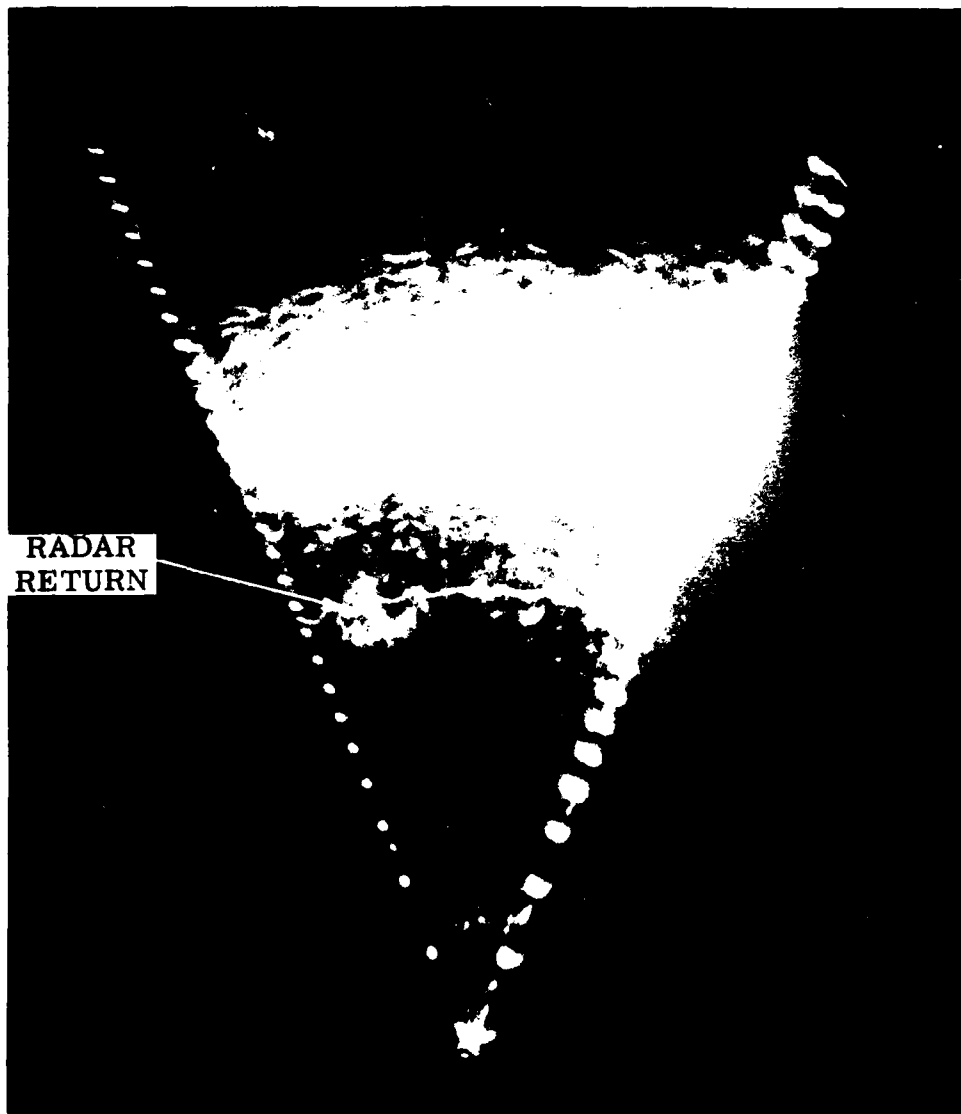
Fig 4.3 Radar Photography, Shot 4. This picture was secured by Tiger 3. It provides ground zero data but, due to distortion, is of little or no value for determining other parameters.

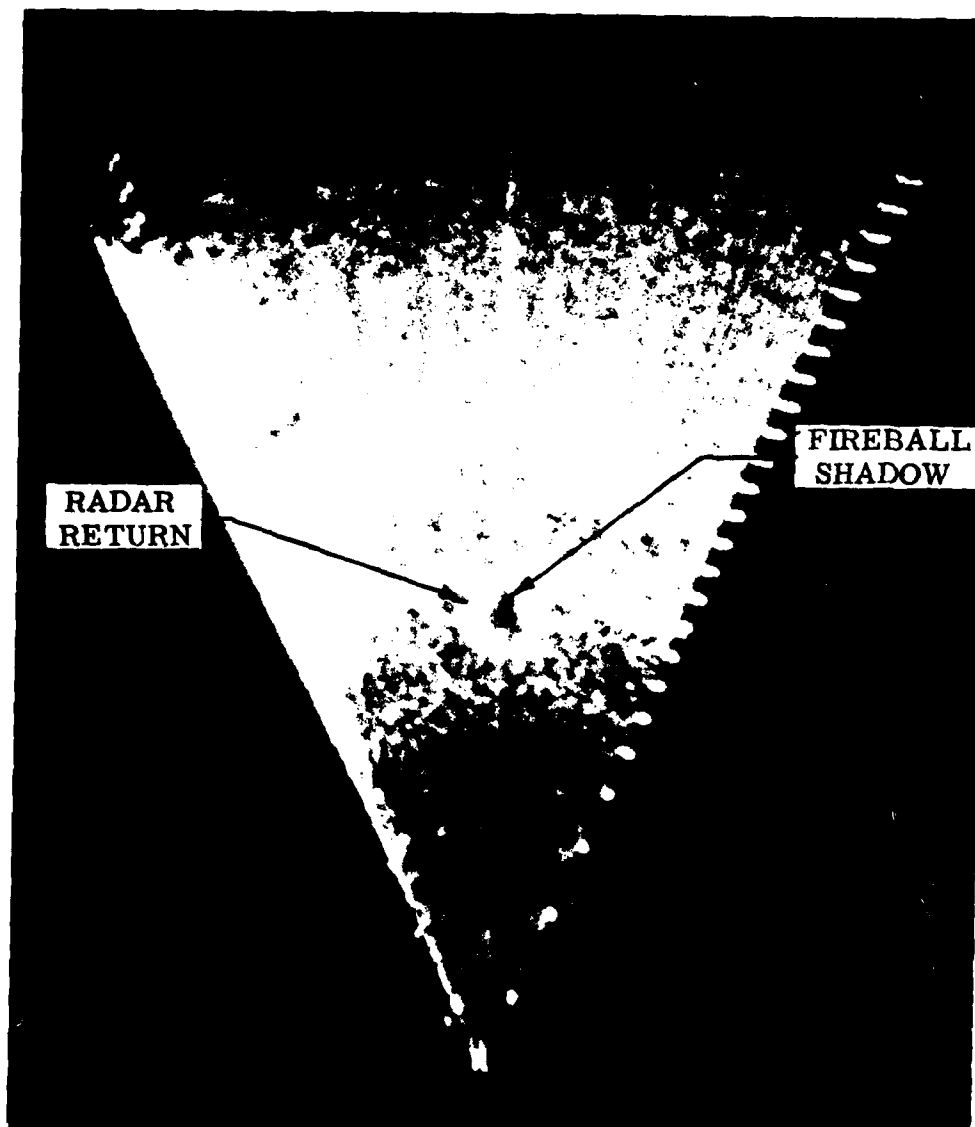
Fig 4.4 Radar Photography, Shot 5. This picture was secured by Tiger 1, and illustrates a so-called horseshoe return. All IBDA parameters may be secured from photography of this type, although attainable yield accuracy is presently unknown.

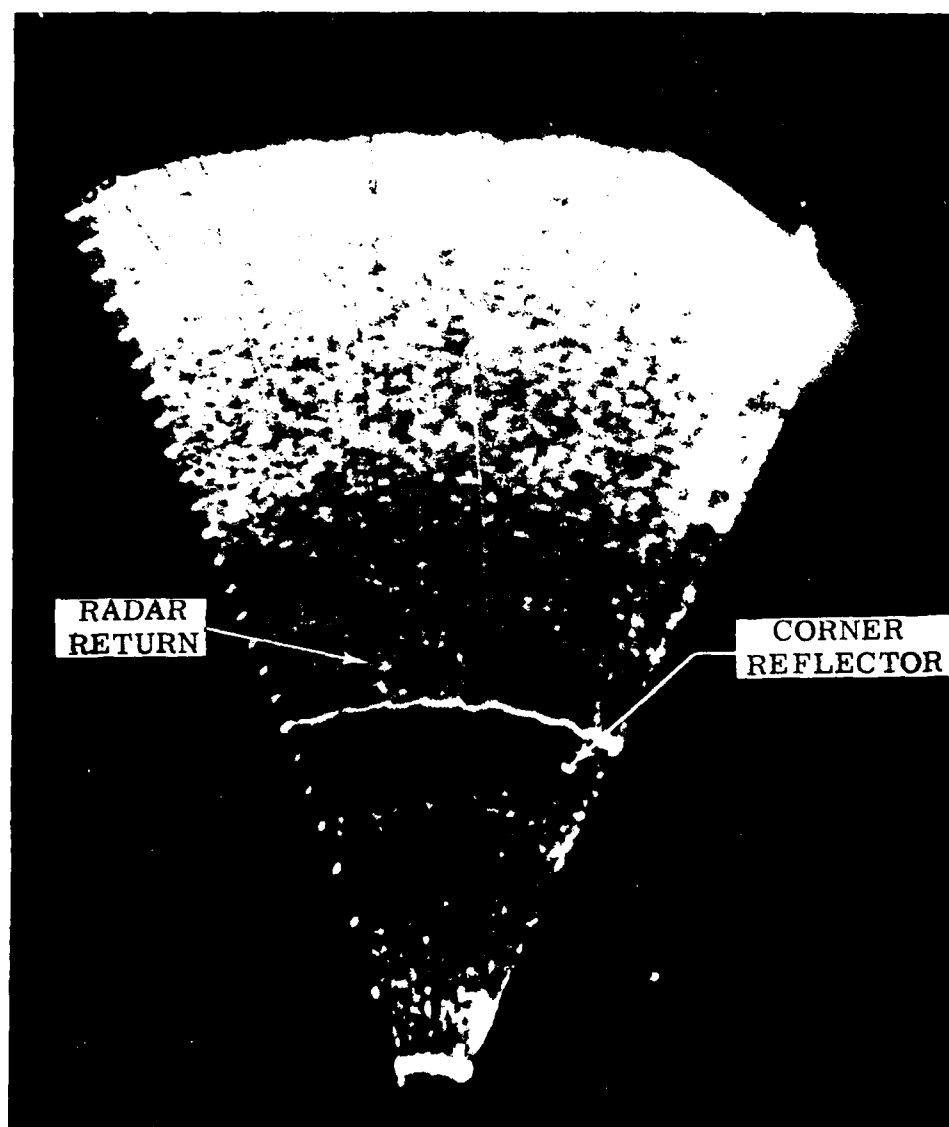
Fig 4.5 Radar Photography, Shot 5. This picture was secured by Tiger 3. Only ground zero may be determined from a circular return of this type. Note the excellent radar fix afforded by the return from a corner reflector.

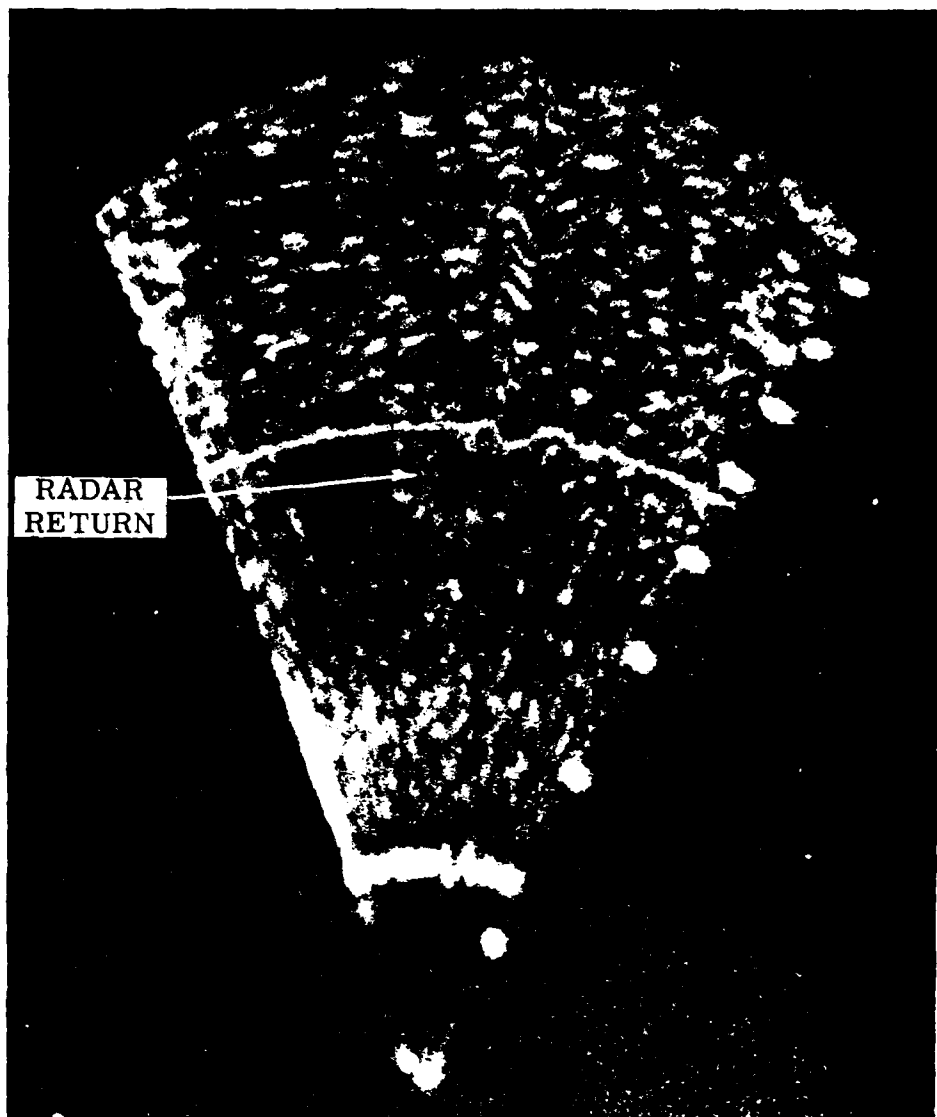
Fig 4.6 Radar Photography, Shot 6. This picture was secured by Tiger 1. Much detail has been lost in reproduction. Only ground zero may be obtained from a circular return of this type.

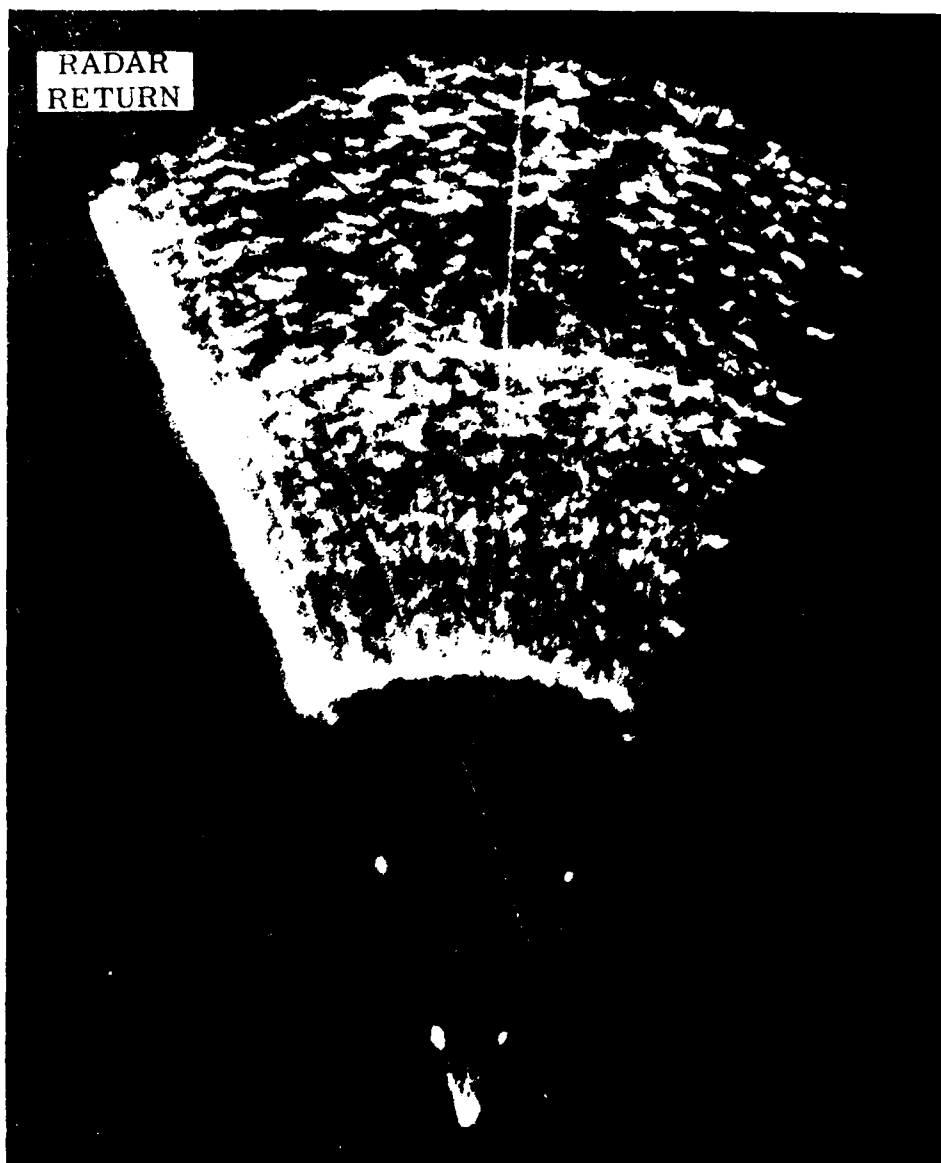
Fig 4.7 Radar Photography, Shot 6. This picture was secured by Tiger 3. This is a circular return which enables ground zero calculations, but the distortion would probably introduce an error on the order of several hundred feet.

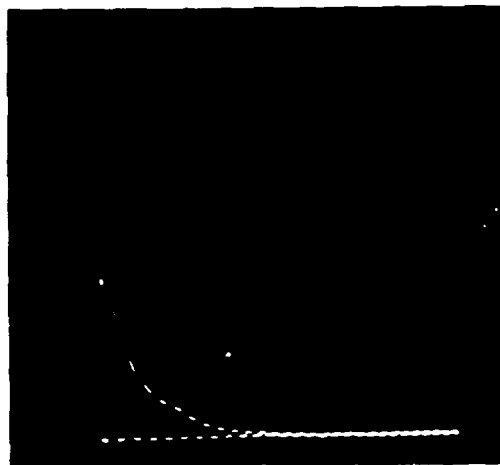
Fig 4.8 Bhangmeter Data, Shot 3.
This photograph demonstrates the
single failure incurred by Project 6.4

Bhangmeter performance was highly satisfactory. Twelve attempts, two instruments on each of six shots, were made to obtain yield data. Only one of these attempts failed. This failure was probably caused by a faulty photocell, plus the use of a Neutral Density 1 filter. In any event, the light intensity trace dropped down to the base line; and remained there. Consequently, no minimum could be determined. (See Figs 4.8 and 4.9)

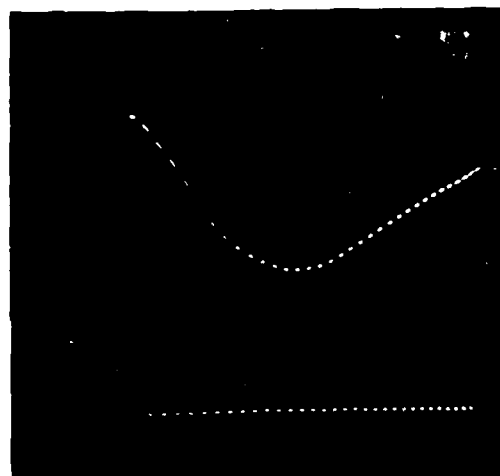
Fig 4.9 Bhangmeter Data, Shot 5.
This photograph demonstrates a
typical light intensity versus
time trace as obtained from an E G & G
bhangmeter. Time to minimum was read
as 13.5 milliseconds.
